Audit Case: Performance Audit on Floods Control Measures in Tanzania

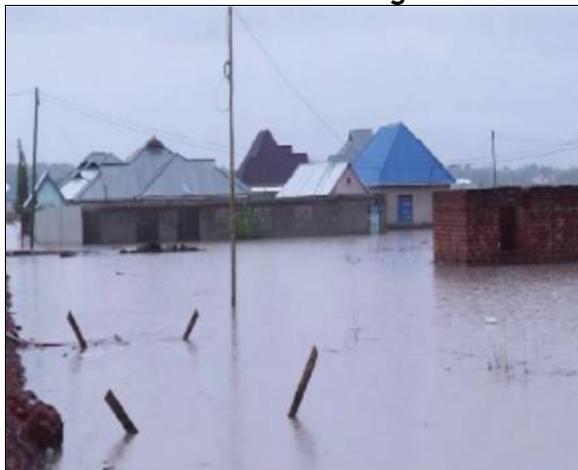
Surveyed and developed area previously identified as a flood-prone area (2019)

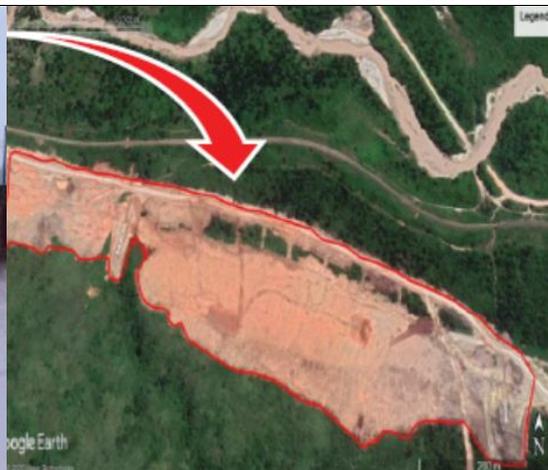
Cultivated Plantation (Forest) section that led to the accumulation of sediments along Msimbazi Reiver Downstream (*Source: Google Earth Pro-Satellite Pictures, 2020I*)

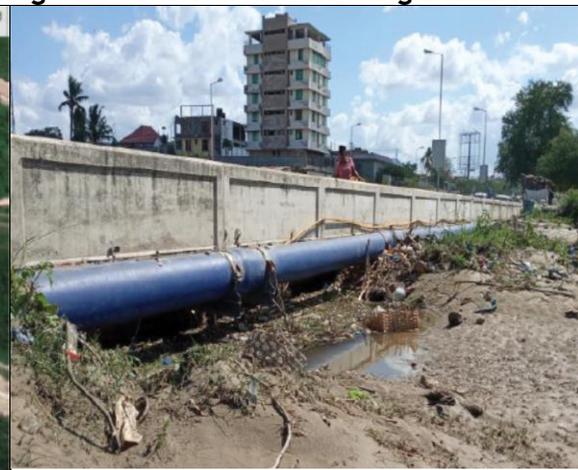
Observed part of Jangwani Bridge with accumulated debris/sediments (2020)

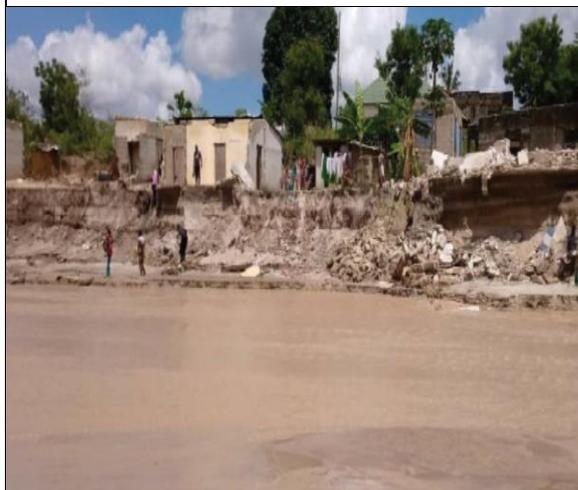
Observed impacts due to widening of river to the nearby residential houses along Msimbazi River caused by Rainfall (Autumn Season, 2020)

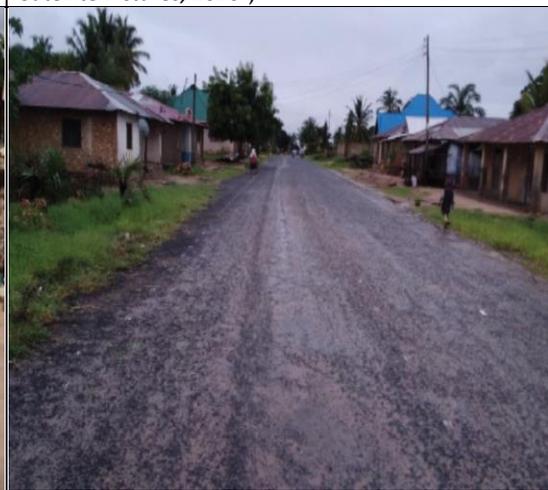
Inadequate Number of Roads with Road-Side Drainages: Despite considering and providing measures for flood control during the planning phase of road network designs, the Audit noted that currently there are no guidelines⁶ for disaster preparedness for road and bridge structures. The Audit revealed that in all visited LGAs there were less than 500 kilometres of the road network that were provided with the side-drainages with the percentage ranging between 0.5 to 15.0 of the available total road networks that range between 297 to 1,664 Km.

Paved tarmac roadway that lacks side drainages (2020)

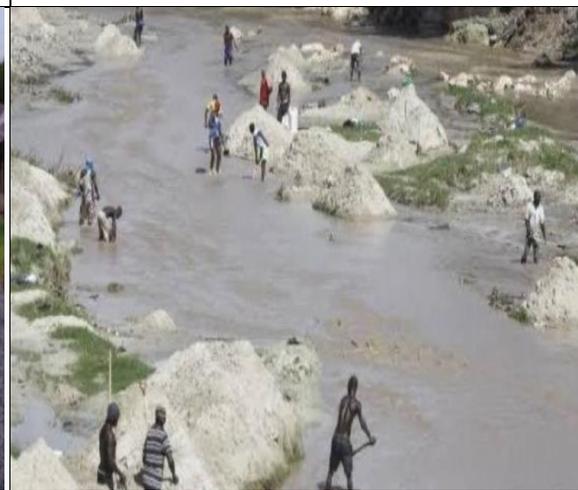
Sand mining along the Mbezi River that crosses along Mbezi and Kawe Wards (2020)
