## Introduction

#### 3.1.1 Non-implementation of planned activities

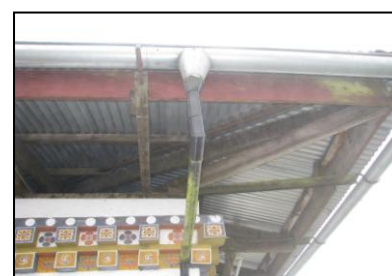
Alternative technologies like roof top rain water harvesting systems, small scale electric pumping systems are being introduced in places like Yongla Goenpa in Pema Gatshel where water sources are not available at appropriate locations;

*Rain water harvesting at Yongla*

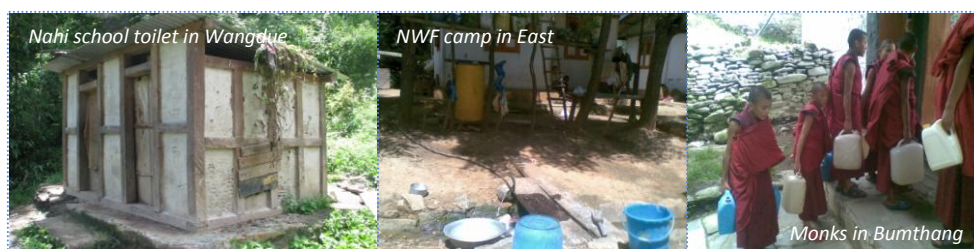
However, instances were observed by RAA, where the water supply and sanitation facilities in many such institutions did not meet the set standards. Proper water supply and sanitation facilities in these institutions demand immediate attention, so as to protect this section of society from common health problems related to unsafe drinking water and hygiene. The most common diseases found in these institutions were typhoid and diarrhoea which are water borne diseases. One of the main reasons cited by the respondents was drying up of water sources in addition to lack of fund.

However, RAA felt that lack of proper coordination & communication between PHED and agencies concerned and non-involvement of PHED in design and construction of such facilities are also other main causes for such situations.

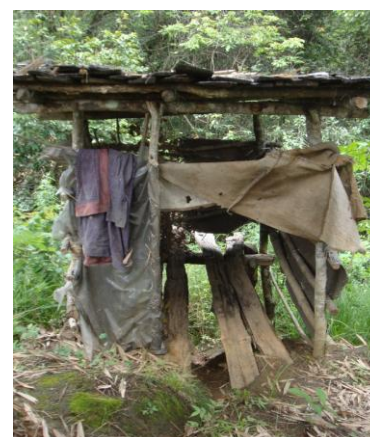
Bhutan’s sanitary conditions vary from place to place and for the rural communities a lot still remains to be improved. A basic pit latrine is all that one needs in villages to meet sanitary requirements. Most villagers were aware of the benefits of improved sanitary practices/facilities, but they still lacked good sanitation habits. While open defecation cases are few in number they still exist.

*Hanging Toilet in Barilum, Kabjisa, Punakha.*

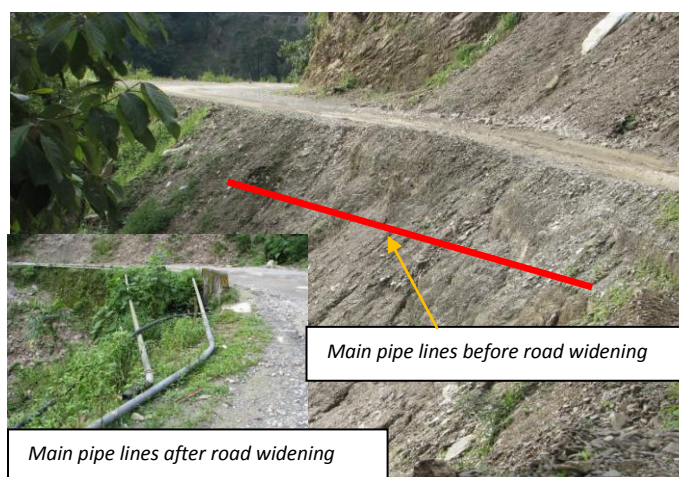
drinking water needs for 111 households with population number of 1,084. The DANTAK's road widening project had damaged more than 800 meters of

pipe lines due to excavation and dumping of debris alongside the road, making the scheme completely nonfunctional.

The geog administration had informally communicated with the officials of the project but failed to get a positive response. Public had also contributed Nu. 58,000.00 and repaired the damaged pipe lines, but due to the continuous activities of the project, it could last only for a month. The lists of eight schemes that have been damaged by such developmental activities observed during site visits are given in *Annexure F*. Many damaged schemes had remained defunct for considerable period of time apparently due to lack of proper co-ordination, communication and accountability amongst agencies carrying out developmental activities.

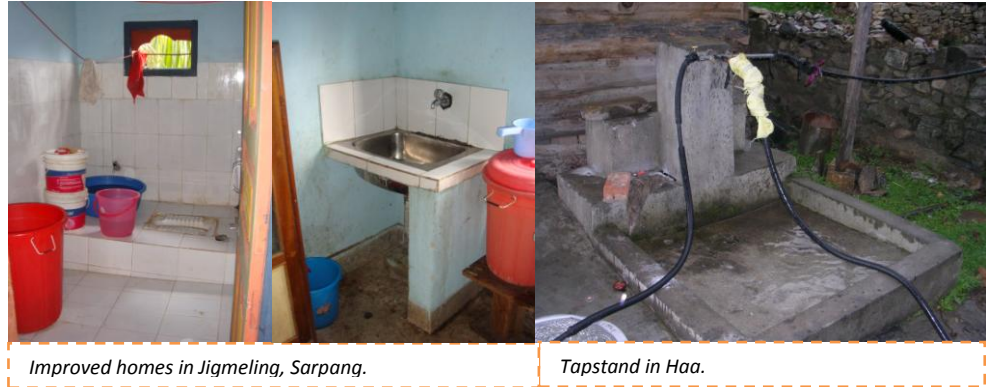
However, areas close to urban centers have proper houses constructed with attached bathrooms and kitchen that have provisions for water connections. This is not planned or provided for by the RWSS schemes. While people cannot be denied the benefits of improved living standards, it becomes an issue when there is not enough water at the source.

In geogs like Katsho, Gelephu and Chengmari which are very close to the Dzongkhag Administrative Centres and municipalities there are demands for accommodations which have led to construction of buildings with multiple dwelling units. This has significantly increased the demand for water which a single or shared tap stands is not expected to provide for. People of Chengmari receive water two times a day but still do not have enough for drinking and basic cooking. For bathing and other household chores people have resorted to using other sources of unsafe water.

This crisis is at present, just the tip of the iceberg and in the long run could turn out to be a very pressing issue. In order to meet these demands the RWSS schemes in similar regions may need to plan a different approach and accordingly implement so as to provide uninterrupted water supply to the communities.

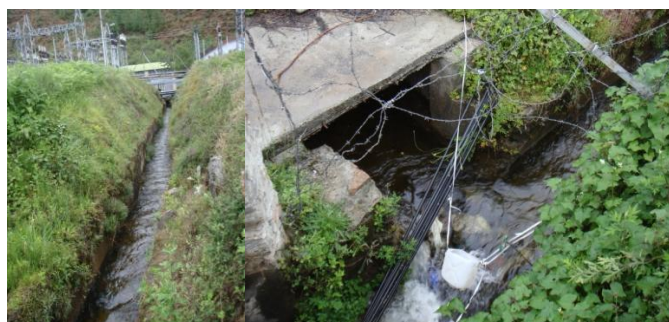
The Jungshina Water Treatment Plant (WTP) collects water from the tail race channel of the Samtenling Mini Hydel. The water runs along the road in an open channel from the hydel to the intake chamber without any covering. The access point is very close to the road. While there is a fence, it does not prevent miscreants from causing intentional hazard to

Source for Jungshina WTP flows in an open channel.

the water supply source. The open channel is also susceptible to contamination and pollution from rain, overflow of excess water from the ground during monsoon, debris and dirt.

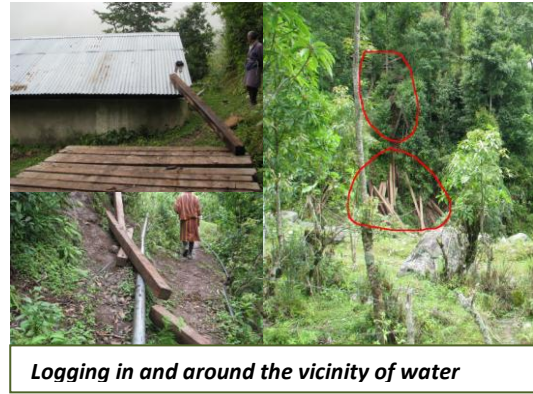
A distinctive instance was noted in Monggar Dzongkhag where the drinking water source and a community forest have been found in the same area. Logging activities were being carried out in and around the vicinity of the drinking water source of the Monggar municipality.

**Logging in and around the vicinity of water**

erosion increase during the wet season. Dzongkhag Administration should look into this matter or else the watersheds will soon be destroyed. The local people will be deprived of the most vital resource for survival.

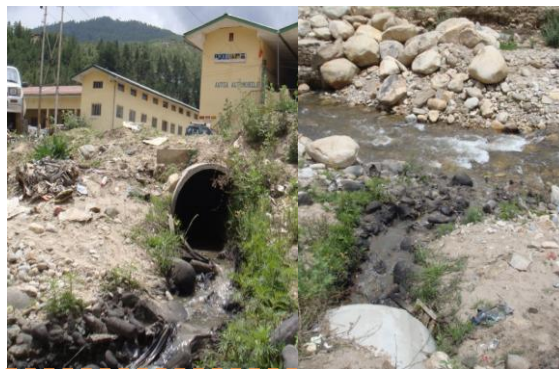
*Effluents from workshops in Olakha flow into stream.*

In Thimphu, wastewater and effluents from workshops can be seen contaminating the *Olarongchu* stream. The new area identified for workshops at Olakha does not have a wastewater treatment plant or facility specifically for these effluents. The area falls along the national highway

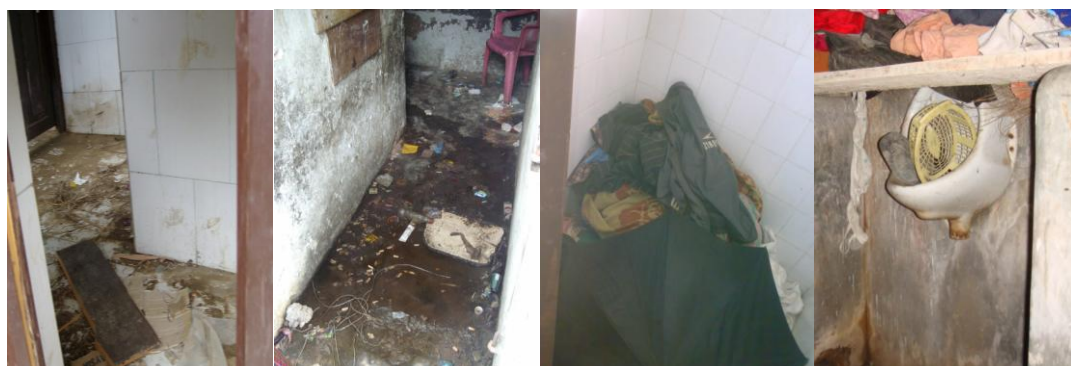
*Public toilets in Thimphu are Dirty and unkempt. Bathroom and urinals filled with clothes in Paro & Gelephu.*

Public toilets of the six towns visited by audit were found unkempt and unhygienic. In Thimphu, the newest public toilet that was constructed at the new truck parking area below Changzamtog in 2008 was found vandalized and abandoned, even the outsourced Bath and Toilet complex at the vegetable market area, was found in a dismal state with unwashed toilets and bathrooms during the visit. Some public toilets were found defunct. While broken faucets, broken wash basins and dirty toilets were common, lack of a good caretaker in most municipal managed public toilets were noted as the main reason for non-maintenance.

The dirty state of public toilets discourages public from using these facilities and instead resorts to fouling surrounding areas, alleys between buildings, bushes along roads and parks. Unhygienic toilets are causes for numerous diseases and this eventually leads to high incidences of sanitation related illnesses and burden the free healthcare facilities provided by the government. Many of the problems with public toilet management can be solved by appointing a dedicated caretaker.

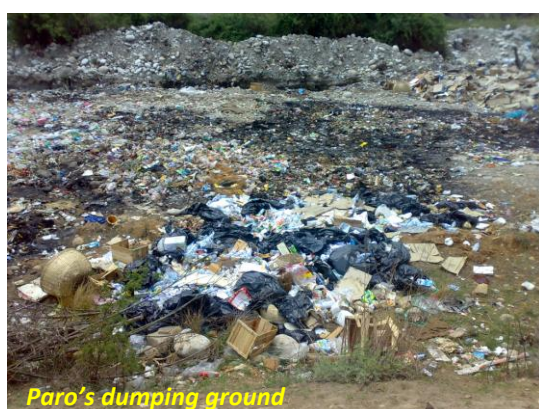
The Paro municipal corporation is responsible for the town's solid waste collection, emptying of septic tanks and their disposals. However, the municipal lacks a properly identified landfill area. The present site is neither planned nor designed to be used as a landfill. The dumping ground is neither demarcated nor fenced to keep out animals and trespassers. Both solid waste and septic waste disposal is done at the present location. The dumping ground is inclusive of a 23 decimals private land and is located upstream from the town's main drinking water supply source.

As the landfill is not designed to handle the wastes, improper disposals may poses many health risks to the town's population as it is located very close to the main town. The private land that is part of the landfill is also slowly becoming toxic and may turn out to be unfit for other activities later

on. Also, the location of the landfill falls above the town's main pumping station that provides the whole town with drinking water.

Serious concerns may arise due to its location as it is very close to the main town and also upstream from the pumping station. Besides harbouring of disease vectors such as rats and flies, the decaying organic wastes generate methane, a greenhouse gas that is more potent than carbon dioxide. Since there is no segregation of waste, numerous chemicals also get mixed up in the landfill. Serious accidents or mishaps arising out of these can endanger the lives of the town's inhabitants.

Also, seepage of toxic leachates into the water table which is the source for the town's drinking water supply can prove hazardous to the entire town's health. Without proper infrastructure to handle wastes, contamination of the soil and groundwater by leakage cannot be avoided. Toxic contaminations of soils are known to have ill effects even after many years of the site being discontinued for such uses.
